Reflection on Twenty Years Since the Loss of the Columbia

By Graduate Student Garrison S. Osborne and Associate Professor Stephen A. E. Miller,
University of Florida Department of Mechanical and Aerospace Engineering

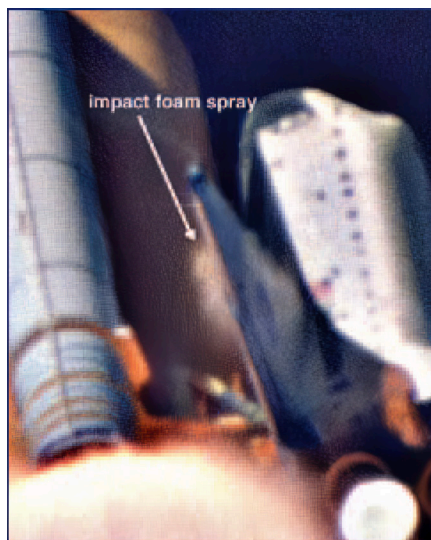
The Crew of STS-107 (see Fig. 1) launched aboard the Columbia on a beautiful Florida day, January 16th, 2003, with blue sky, cool 60° F air, and winds of max. 12.3 mph. At 81.7 seconds, a piece of foam protecting the left bipod strut detached due to sudden wind shear and collided with the left-wing leading edge of Columbia (see Fig. 2). The relative velocity of the foam at impact was nearly 490 mph and damaged a panel.

Fig. 2. Foam impact and subsequent spray pattern (CAIB vol. 1, NASA).
